ONE WORLD TRADE CENTER FIRE

New York, N.Y.
February 13, 1975

WTCI-486-P

HIGH-RISE FIRE SAFETY

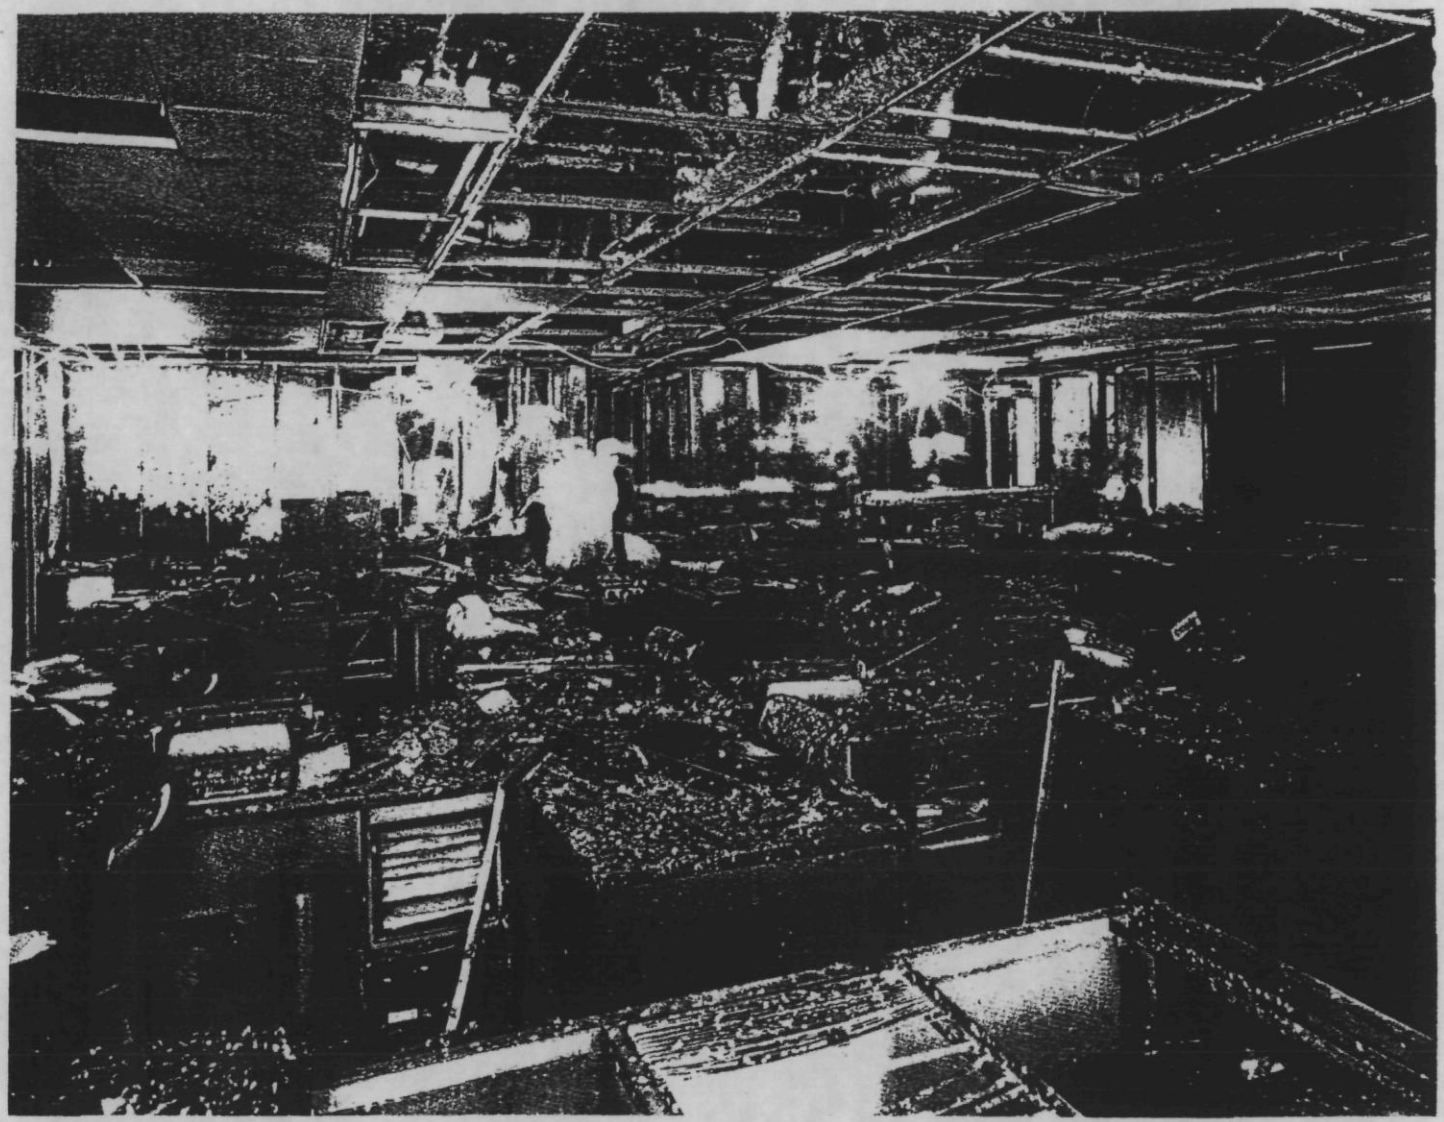
R. J. Saunders office on 11th floor file room is at left and office of fire origin is behind partition at right of picture.

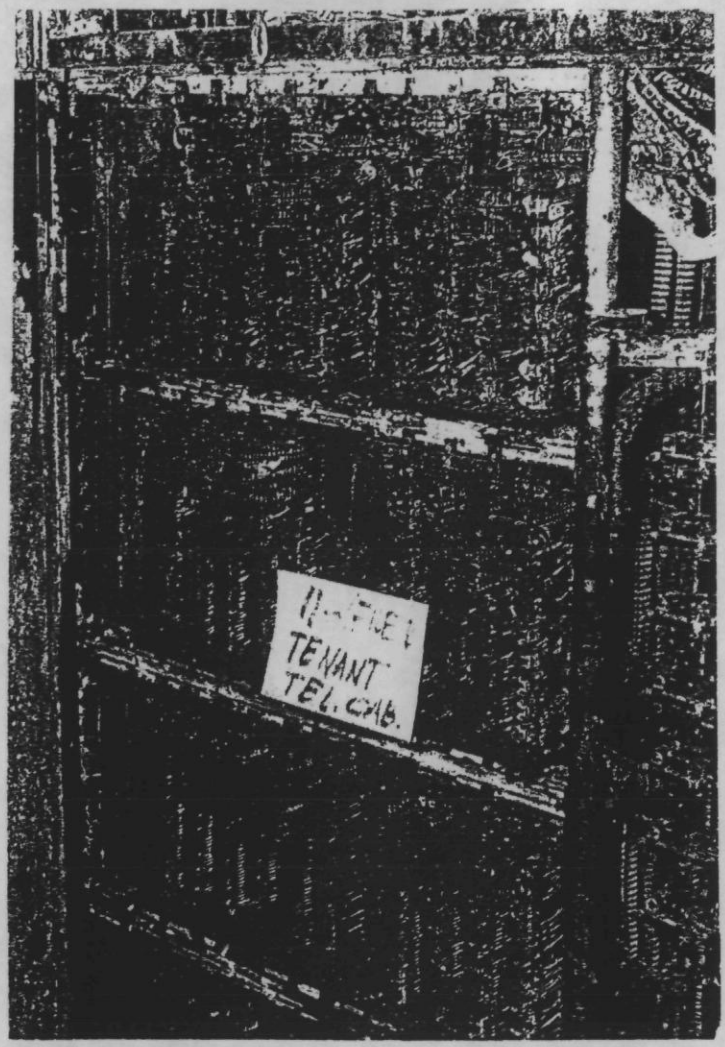
Proprietary telephone cabinet located at west end of file room on 11th floor.

detector. Smoke had to enter and spread through the plenum to the western end until a sufficient amount entered the detector to cause it to send an alarm.

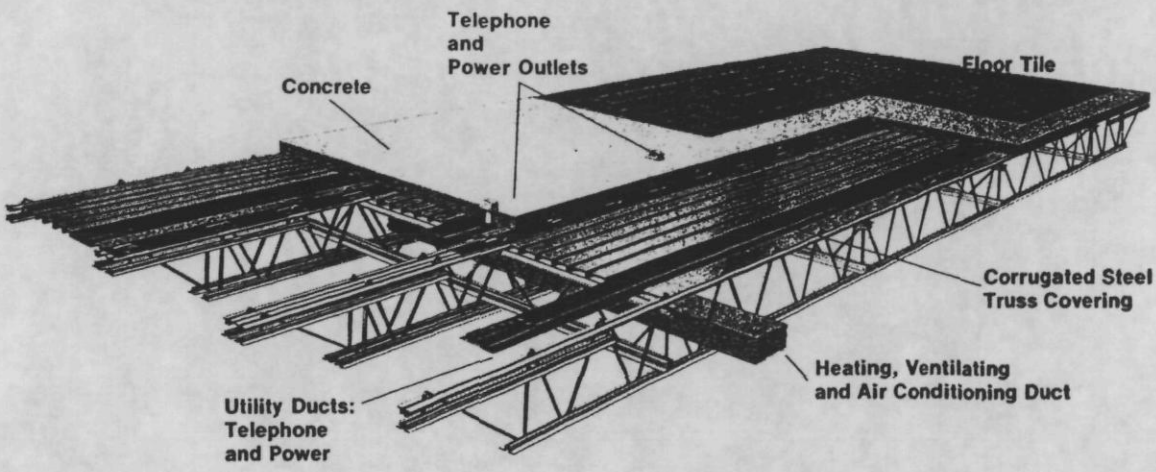
Floor truss in close-up detail. Following placement of truss, *the corrugated top was covered by concrete floor slab* and tile surface. Underneath, a network of utility and air conditioning ducts traverse the 32-inch deep-cavity.

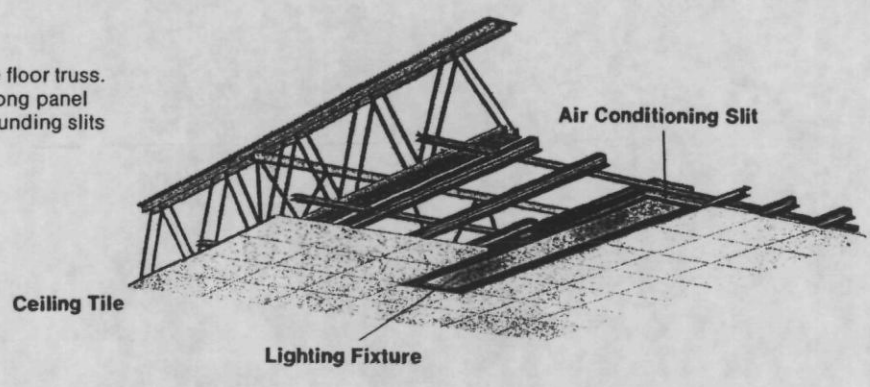
Looking upward at the same floor truss. Ceiling tile is in place. The long panel provides lighting, with surrounding slits for air conditioning.

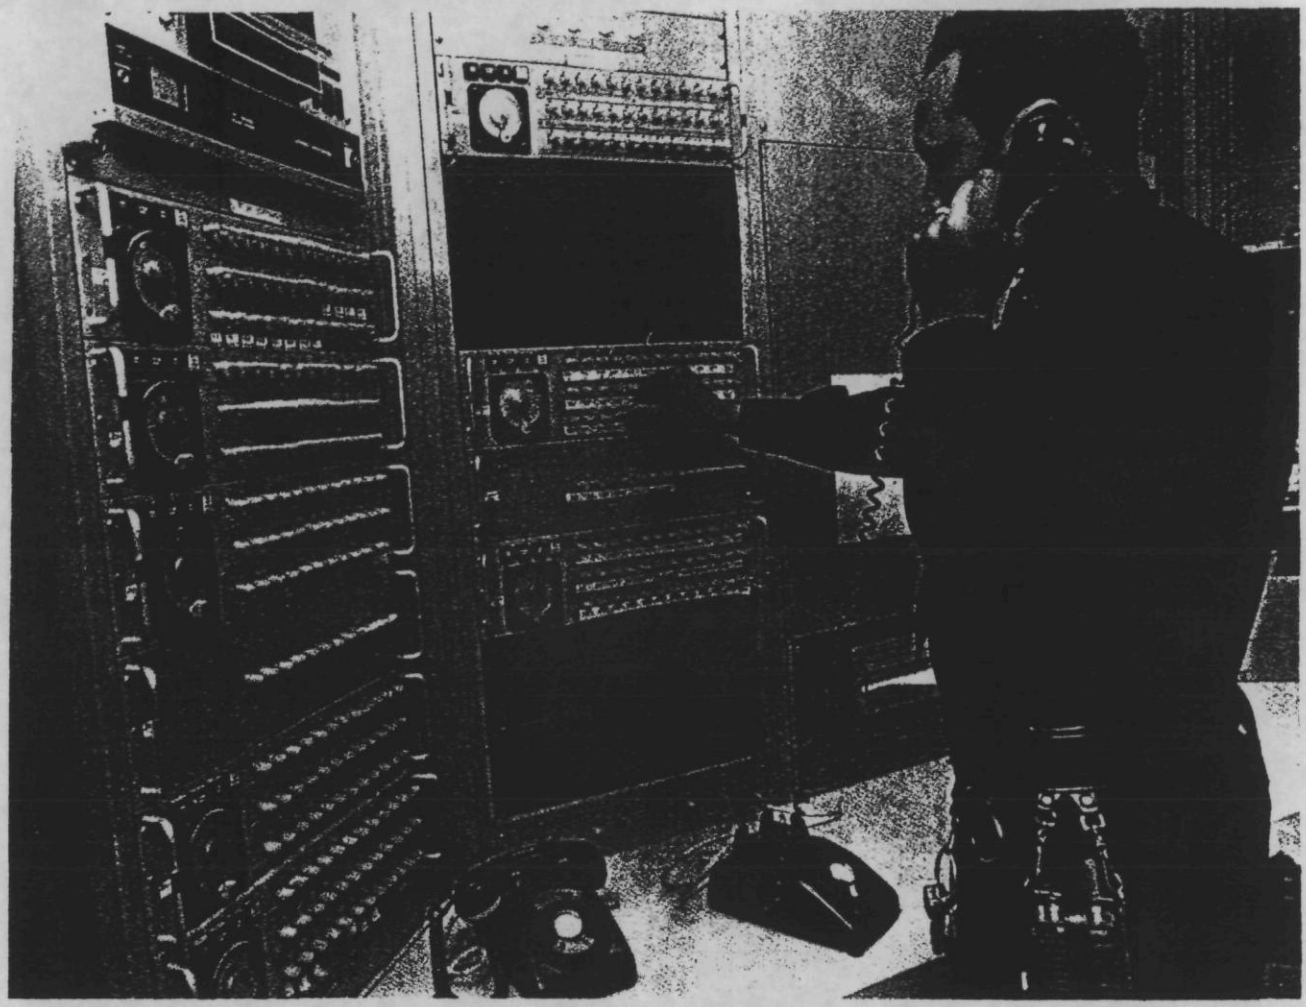
Control panel in World Trade Police Headquarters. Fire Alarms are received here and are transmitted to Fire Department via alarm box here or by "Hot Line" telephone.

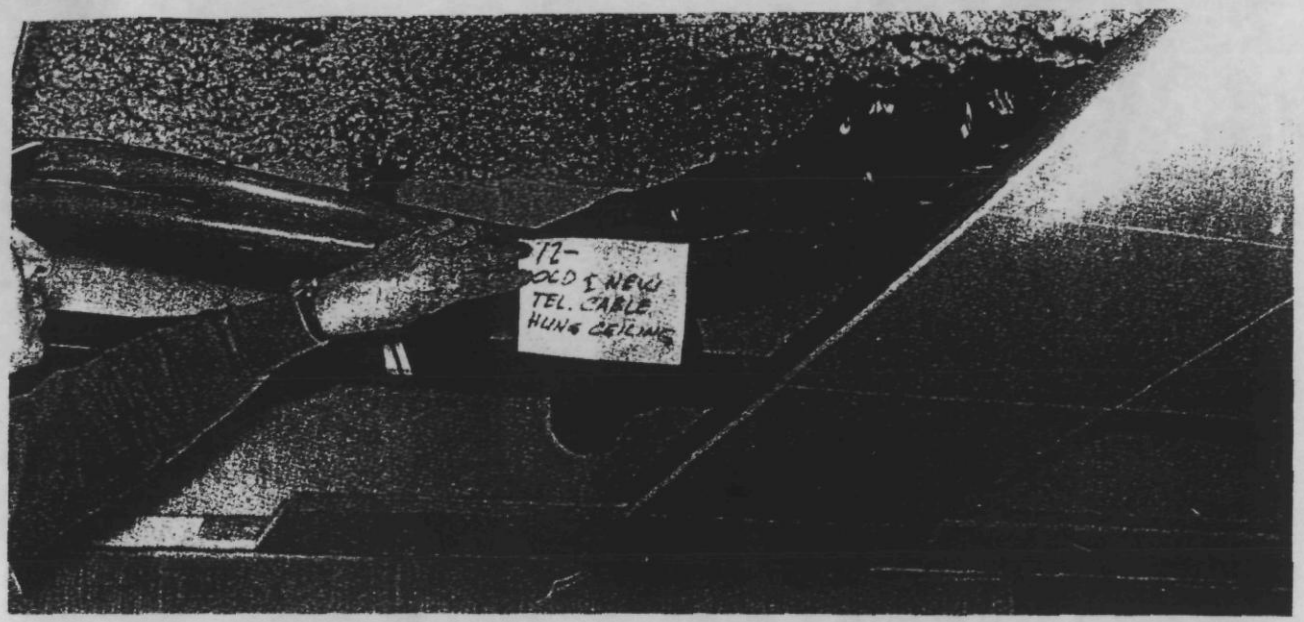
Telephone cables in plenum above hung ceiling. Note opening in closet wall.

It is recommended that communication wiring and equipment be subject to the same inspection procedure and requirements for compliance with the National Electric Code as is required of power wiring.
